# Property Inspection Report

Client(s): **Sample Report**

Property address: **123 Any Road**

Inspection date: **Wednesday, October 22, 2014**

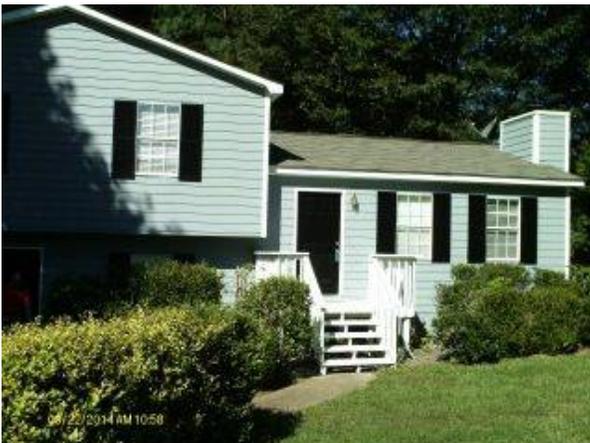
**Photo X-1**

There is no drainage/gutter system in place. This will allow the water to drain down to the foundation, and over time will erode and possibly cause water intrusion into the crawlspace. Recommend a licensed contractor further evaluate and install a new drainage/gutter system to prevent the possibility of future damage.

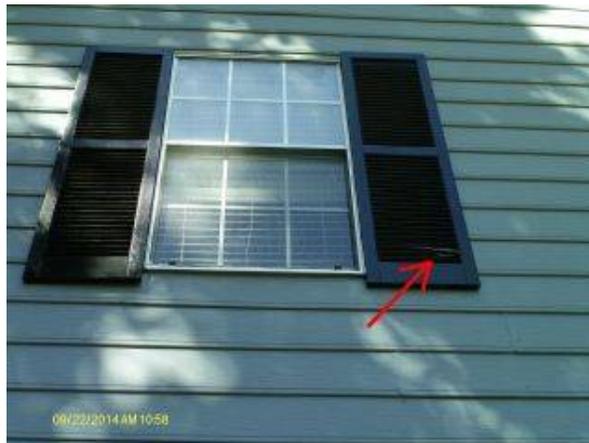
**Photo X-2**

This window shutter in the front of the house is damaged. Recommend the current owner repair and/or replace as deemed necessary.

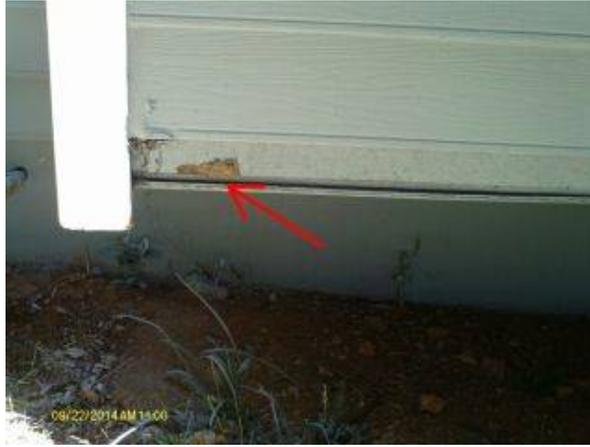
**Photo X-4**

This is one, of several areas of siding, that has severely deteriorated. Recommend a licensed contractor further evaluate and remove and replace as deemed necessary to prevent further damage.

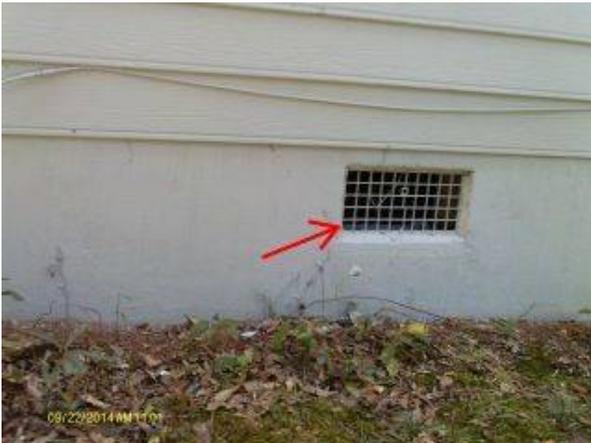
**Photo X-5**

There are no screens on any of the crawlspace vents. Recommend a licensed contractor further evaluate and install said screens on all crawlspace vents to prevent insects and vermins from entering said structure.

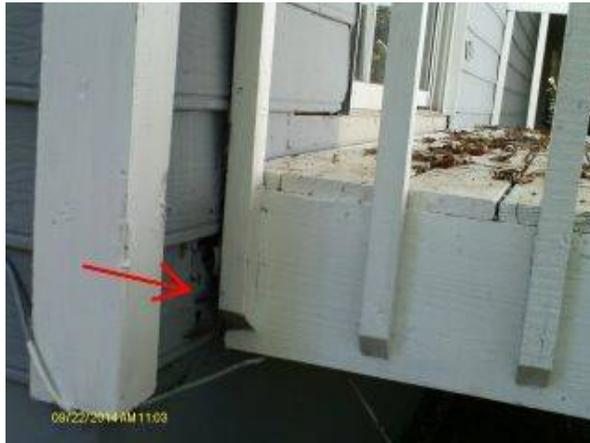
**Photo X-6**

This is another area of siding, near the back deck, that has severely deteriorated. Recommend a licensed contractor further evaluate and remove and replace, as deemed necessary, to prevent further damage.

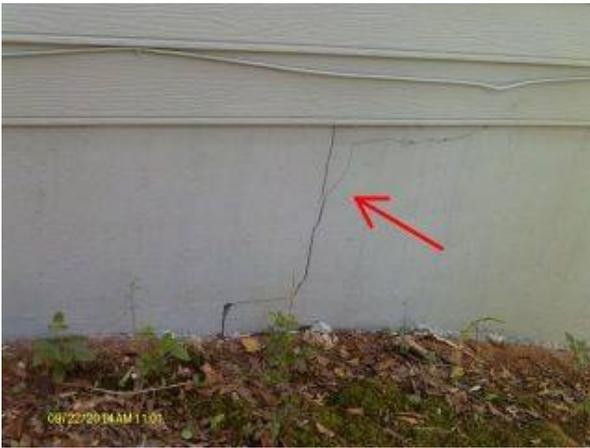
**Photo X-7**  
 This is one of two foundation cracks. They appear to have occurred over the 27 years, which is the age of the house. Recommend a licensed contractor further evaluate and repair as deemed necessary.

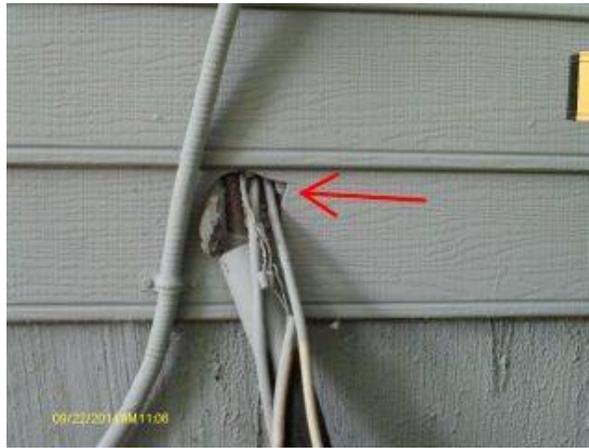
**Photo X-8**  
 This is a gap penetration at the back side of the house. Recommend a licensed contractor further evaluate and repair as deemed necessary to prevent insects and vermins from entering said structure.

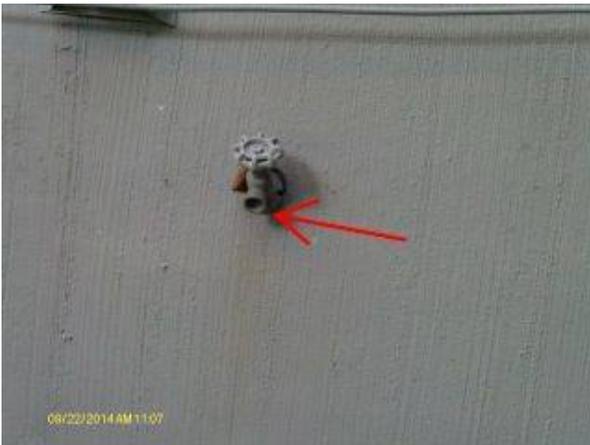
**Photo X-9**  
 There are no anti-syphon adapters on any of the hose bibs. Recommend the potential buyer purchase said adapters at a home improvement store and affix to prevent backflow contamination to the potable water system.

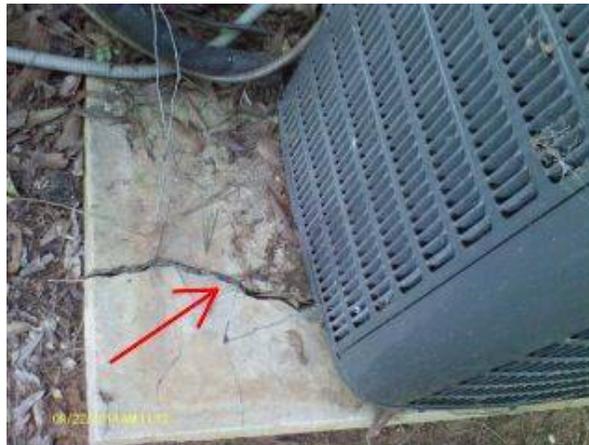
**Photo X-10**  
 The A/C Condensing Unit platform has severely cracked, and over time will not provide a level platform for the A/C unit, thus causing unnecessary wear on the cooling fins. Recommend a licensed contractor further evaluate and remove and replace as deemed necessary.

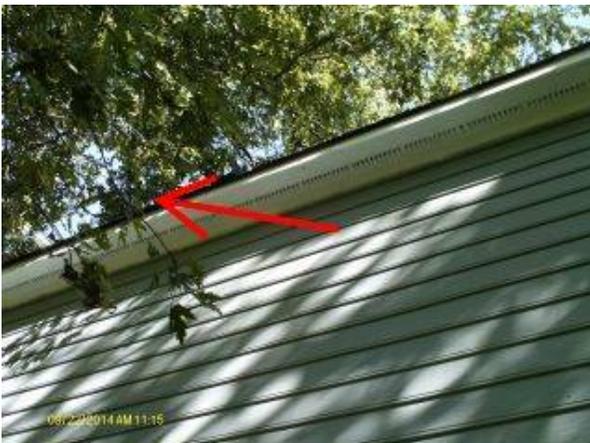
**Photo X-11**

There are many large tree limbs that are overhanging the roof, and also on the roof. This is a serious safety hazard. Recommend a licensed Arborist further evaluate and remove all tree limbs at least 10 feet from the exterior structure of the house to prevent the possibility of serious damage and/or serious injury.

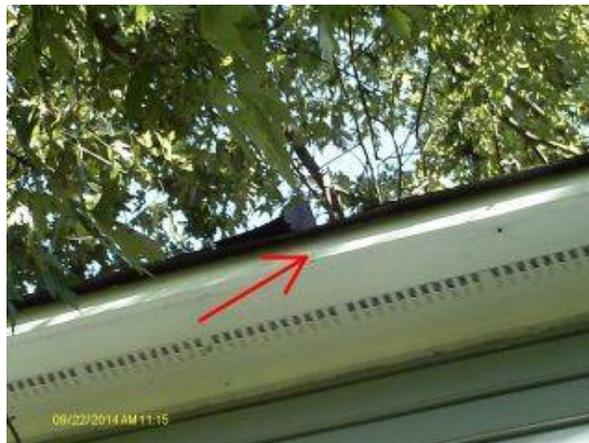
**Photo X-12**

This section of roof shingles on the left side of the house is damaged. Recommend a licensed contractor further evaluate and remove and replace as deemed necessary.

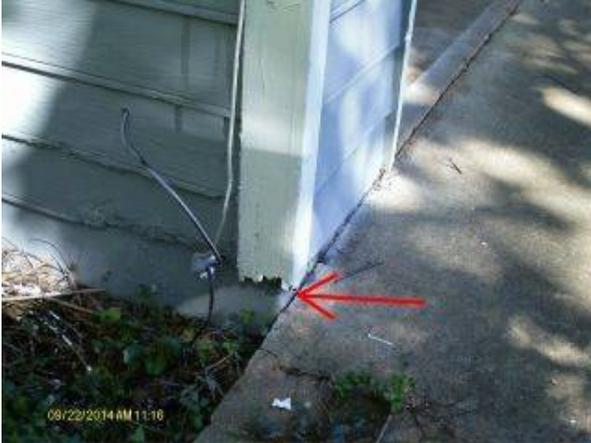
**Photo X-13**

There are one or more wood trim boards that have wood rot and need to be replaced. Recommend a licensed contractor further evaluate and remove and replace as deemed necessary.

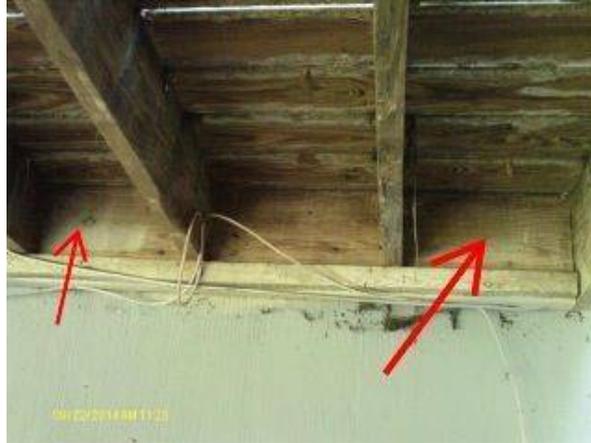
**Photo X-14**

The deck is improperly installed to the house. It is not secured with lagging bolts. Recommend a licensed contractor evaluate, and correct as deemed necessary.

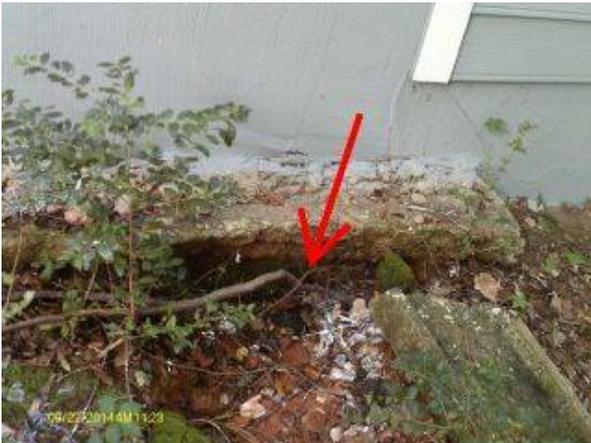
**Photo X-15**

This is an area of erosion around the foundation of the house. This could potentially be a source of water leakage and damage to the foundation. Recommend a licensed contractor further evaluate and repair as deemed necessary.

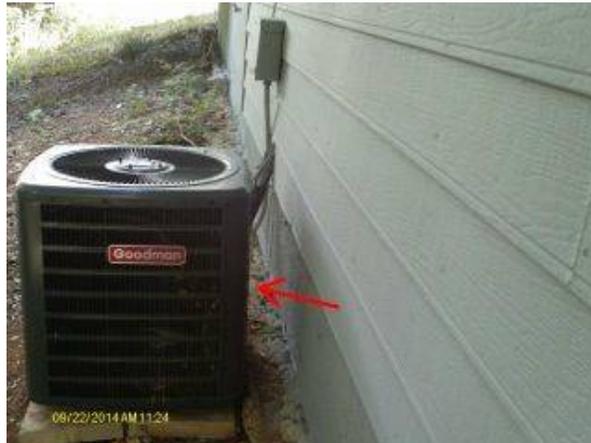
**Photo X-16**

The air conditioning condenser is mounted too close to the house. There needs to be a minimum of 12 inches to allow for proper circulation of air to effectively cool the house. Recommend a licensed contractor further evaluate and repair as necessary.

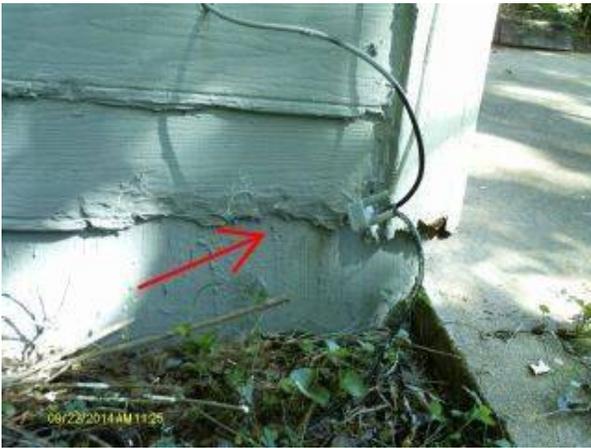
**Photo X-17**  
 This area of siding has severely deteriorated and has been covered with paint. Recommend a licensed contractor further evaluate and remove and replace as deemed necessary to prevent further damage.

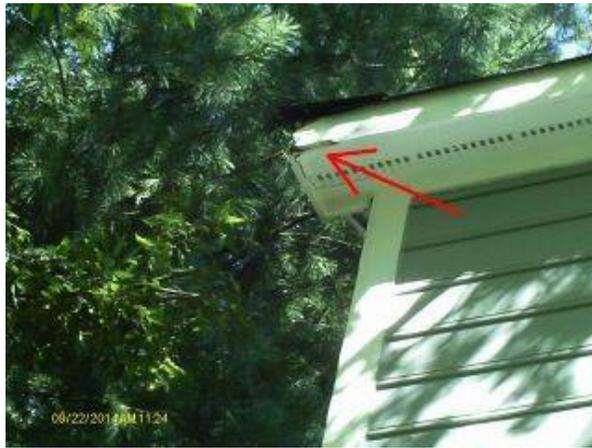
**Photo X-18**  
 This fascia board is deteriorating and is a potential entry for water and water damage. Recommend a licensed contractor further evaluate and repair as deemed necessary.

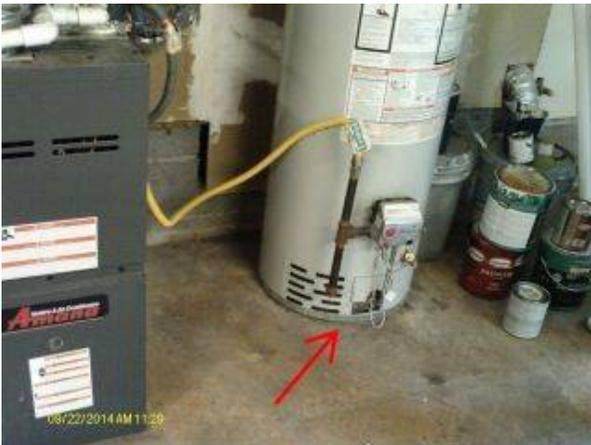
**Photo X-19**  
 This gas hot water heater sitting on the garage floor needs to be raised 18 inches of the floor to prevent possible explosion from a spark and/or fuel vapor. Recommend a licensed plumber further evaluate and repair as deemed necessary to prevent serious injury and/or damage in the future.

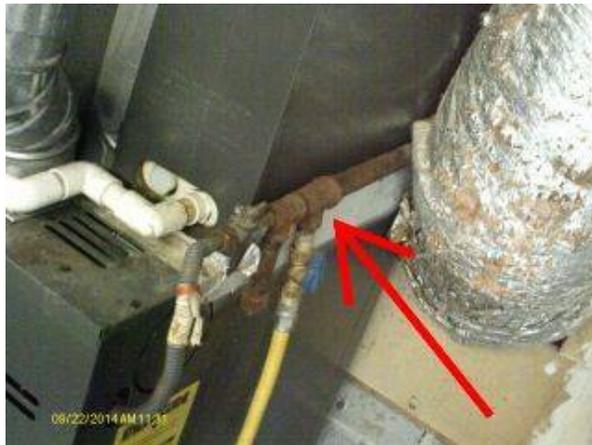
**Photo X-20**  
 This gas supply line to the furnace is rusted and could cause leaking in the future. Recommend a licensed contractor further evaluate and repair as deemed necessary.

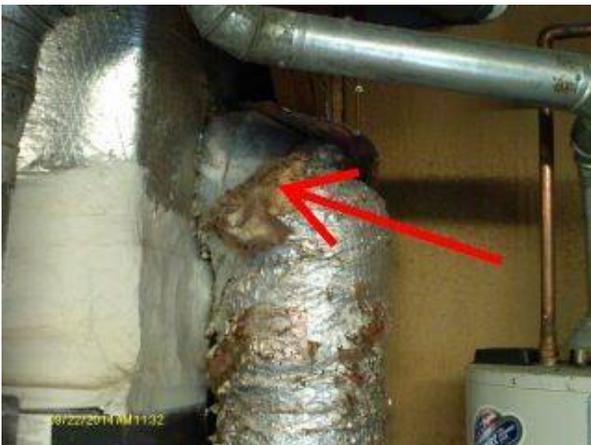
**Photo X-21**

The insulation surrounding the ventilation tubing has severely deteriorated and needs to be removed and replaced. Recommend a licensed contractor further evaluate and repair as deemed necessary.

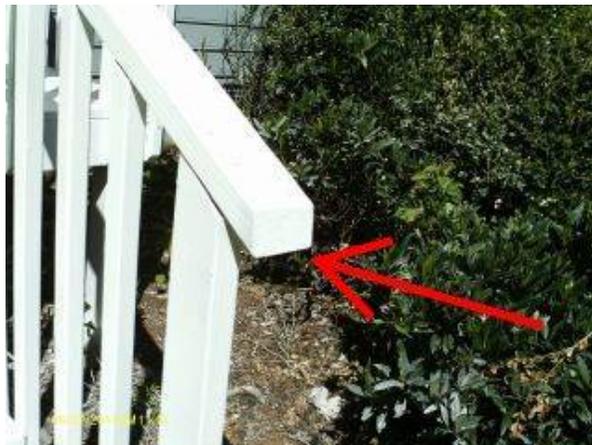
**Photo X-22**

The end of this hand rail should be extended to the ground to prevent catching clothing on it. Recommend a licensed contractor further evaluate and remove and replace as deemed necessary.

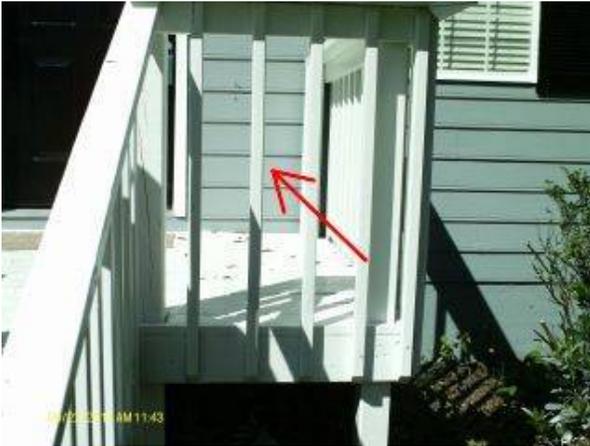
**Photo X-23**  
The guard rails have too large of a gap between them. The gap should be no larger than 4 inches. Recommend a licensed contractor further evaluate and remove and replace as deemed necessary.

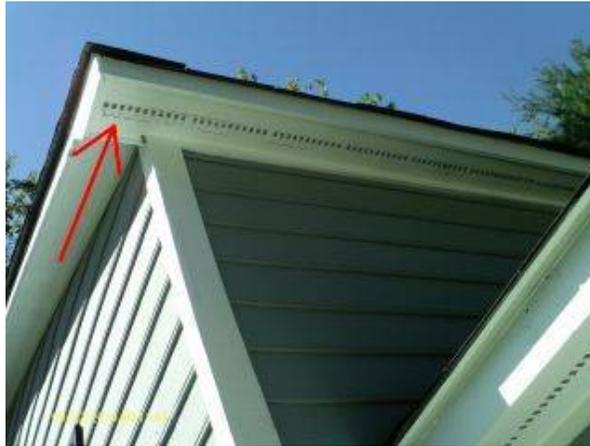
**Photo X-24**  
Many of the soffit vents are blocked with paint. This could affect proper roof ventilation, trapping moisture in the roof area. Recommend a licensed contractor further evaluate and repair and/or replace as deemed necessary.

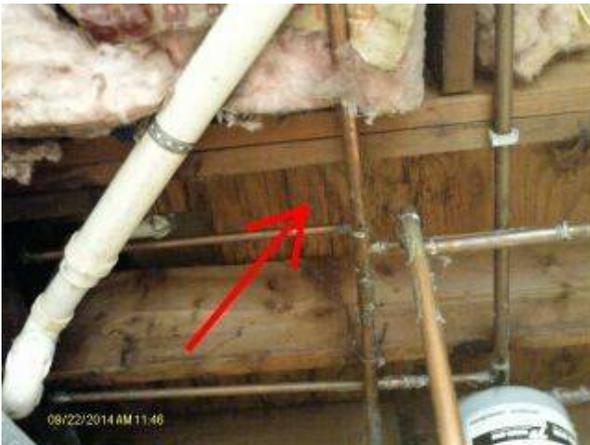
**Photo X-25**  
This sub flooring needs to have insulation installed for proper insulation and to prevent cold spots on the floor above. Recommend a licensed contractor further evaluate and repair as deemed necessary.

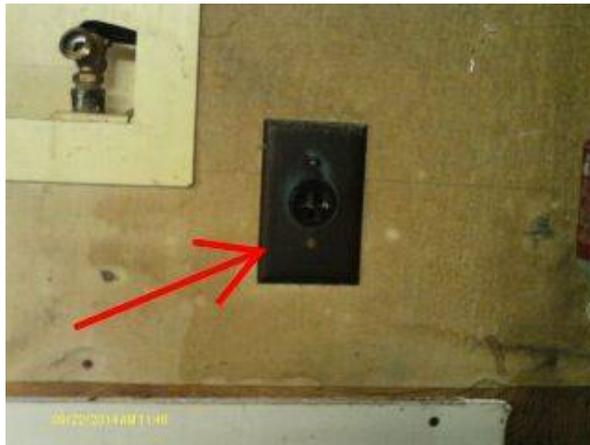
**Photo X-26**  
This electrical outlet in the garage is not GFCI protected. Recommend a licensed electrician further evaluate and remove and replace with a GFCI certified outlet to prevent possible electrical shock.

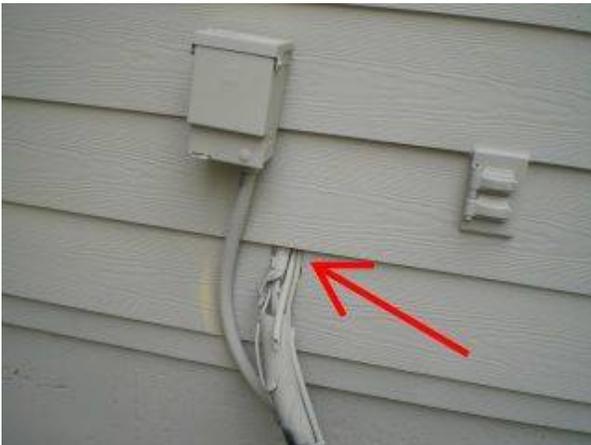
**Photo X-27**  
 This is a gap penetration at the back side of the house. Recommend a licensed contractor further evaluate and repair as deemed necessary to prevent insects and vermins from entering said structure.

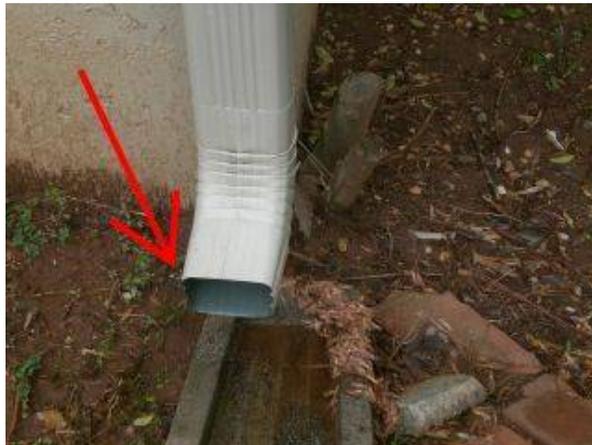
**Photo X-28**  
 This downspout is set too high and not centered over the tray. Rain water can collect and pool near the foundation possibly causing damage to and penetrating the foundation over time. Recommend a licensed contractor further evaluate and repair as deemed necessary.

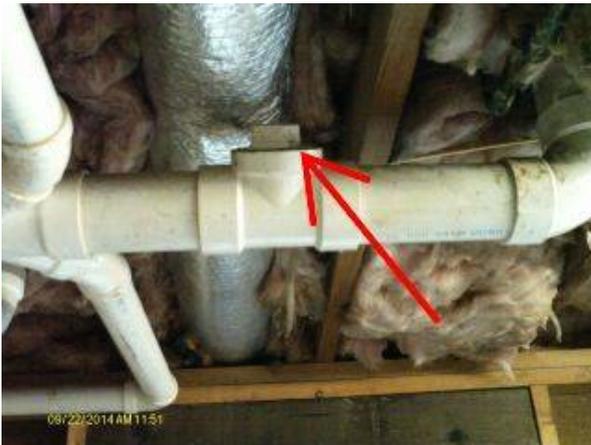
**Photo X-29**  
 This sewer drain clean out in the ceiling of the garage is inaccessible. Recommend a licensed plumber further evaluate and repair as deemed necessary.

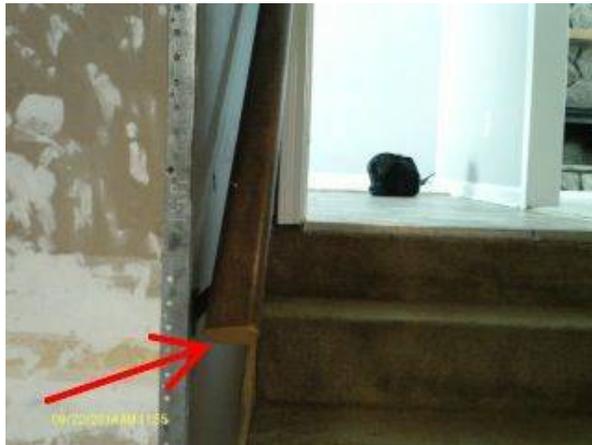
**Photo X-30**  
 The end of this hand rail should be closed off to the wall or extended to the floor to prevent catching clothing on it. Recommend a licensed contractor further evaluate and remove and replace as deemed necessary.

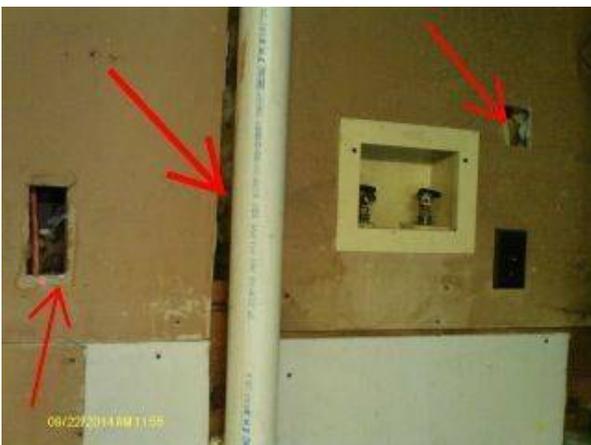
**Photo X-31**

This is a fire wall from the garage to a living space, this wall should have no penetrations in it. There are several breeches to this wall, it will not slow down a fire to the living space. Recommend a licensed contractor further evaluate and remove and replace as deemed necessary. This is a code violation and a safety hazard.

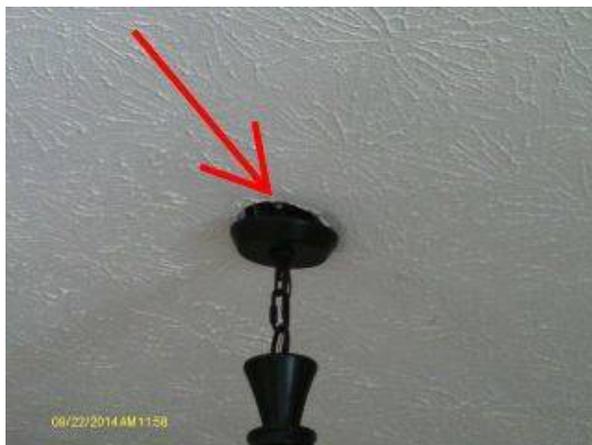
**Photo X-32**

This mounting bracket for the light fixture in the kitchen area is loose. Recommend a licensed contractor further evaluate and repair as deemed necessary.

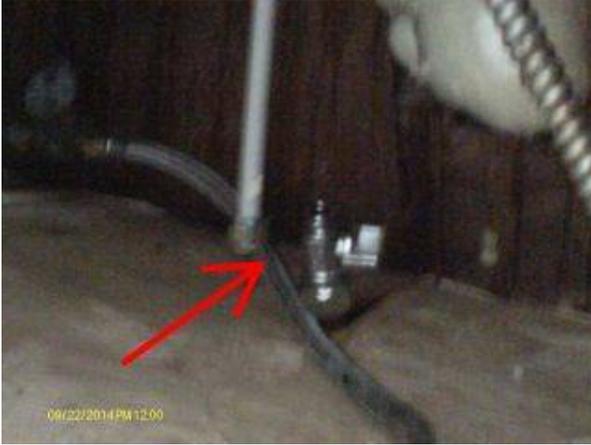
**Photo X-33**  
The water lines underneath the kitchen sink area are not connected properly and are leaking. Recommend a licensed plumber further evaluate and remove and replace with the correct length of hoses to prevent the possibility of future water damage.

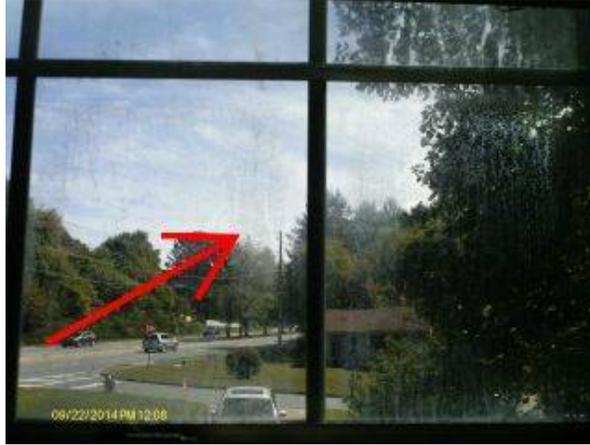
**Photo X-34**  
This window in the Master Bedroom has a broken seal, thus causing condensation. Recommend the current owner further evaluate and remove and replace as deemed necessary.

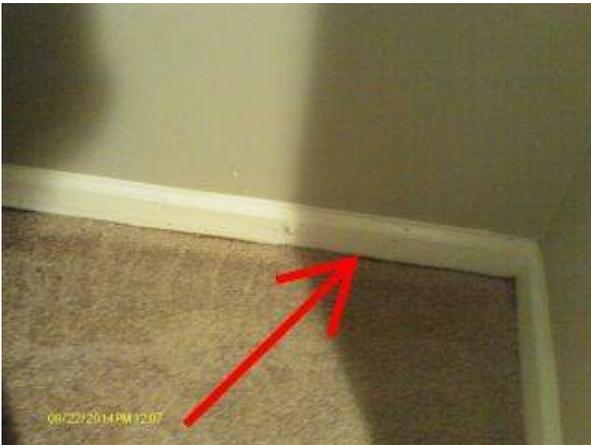
**Photo X-35**  
The carpeting in several of the rooms have gaps where the carpet should meet the wood trim. Recommend a licensed contractor further evaluate and repair as deemed necessary.
